DEPARTMENT OF TRANSPORTATION

Contract #: 04-0120F4Cty: SF/ALA Rte: 80 PM: 13.2/13.9File #: 1.28**WELDING INSPECTION REPORT****Resident Engineer:** Casey, William**Address:** 333 Burma Road**City:** Oakland, CA 94607**Report No:** WIR-029406**Date Inspected:** 11-Apr-2013**Project Name:** SAS Superstructure**OSM Arrival Time:** 700**Prime Contractor:** American Bridge/Fluor Enterprises, a JV**OSM Departure Time:** 1730**Contractor:** American Bridge/Fluor Enterprises, a JV**Location:** Job Site**CWI Name:** See below.**CWI Present:** Yes No**Inspected CWI report:** Yes No N/A**Rod Oven in Use:** Yes No N/A**Electrode to specification:** Yes No N/A**Weld Procedures Followed:** Yes No N/A**Qualified Welders:** Yes No N/A**Verified Joint Fit-up:** Yes No N/A**Approved Drawings:** Yes No N/A**Approved WPS:** Yes No N/A**Delayed / Cancelled:** Yes No N/A**Bridge No:** 34-0006**Component:** Tower**Summary of Items Observed:**

WELDING INSPECTION REPORT

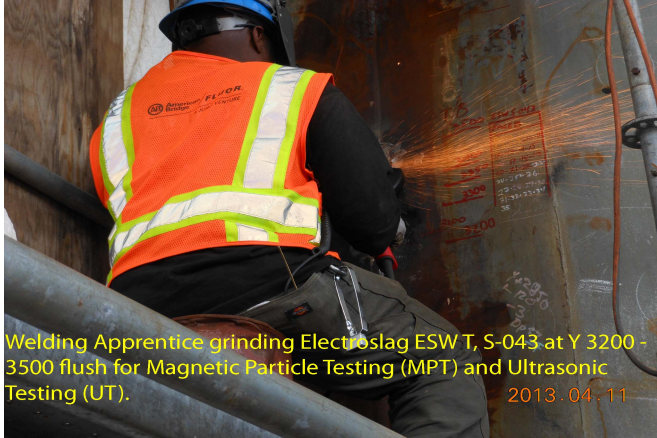
Welding Apprentice grinding Electroslag ESW T, S-043 at Y 3200 - 3500 flush for Magnetic Particle Testing (MPT) and Ultrasonic Testing (UT).
2013.04.11

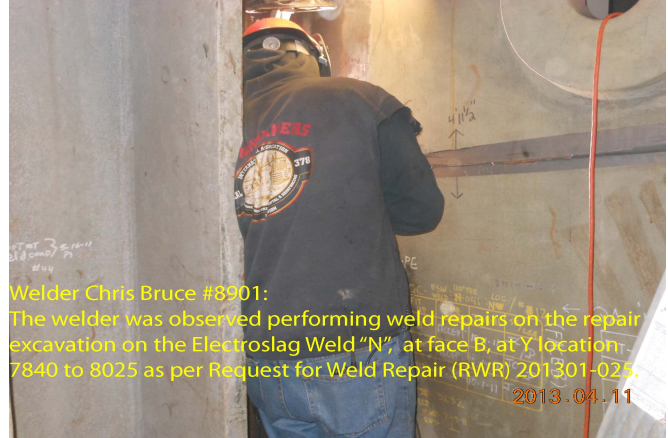
The welder was observed performing weld repairs on the repair excavation on the Electroslag Weld "N", at face B, at Y location 7840 to 8025 as per Request for Weld Repair (RWR) 201301-025 in way of Ultrasonic Testing excavated indications. The welder was observed preheating the weld to over 300 degrees Fahrenheit prior to welding using the Miller ProHeat 35 with heat induction blankets. The welder utilized the Welding Procedure Specification (WPS) ABF-WPS-D15-1000-Repair Rev.3 for Shield Metal Arc Welding (SMAW). The welding parameters were verified by QC Inspector Andrew Keech throughout the day and appeared to be in compliance with the WPS noted above.

Welder Chris Bruce #8901:
The welder was observed performing weld repairs on the repair excavation on the Electroslag Weld "N", at face B, at Y location 7840 to 8025 as per Request for Weld Repair (RWR) 201301-025.
2013.04.11
